**RE: RCRA Notice of Violation
U.S. Coast Guard
MD4690307844**

**Re: Notice of Violation
Compliance Evaluation Inspection
March 30, 2011
EPA ID No. MD4690307844**

The Facility conducts shipbuilding and repairs on Coast Guard Vessels. The Facility also houses operations that support the mission of the Coast Guard and their shipbuilding and repairs. The shipbuilding and repairs of Coast Guard vessels include engine maintenance, painting, and repairing ship electronics. The Facility is host command to 12 units (ANT Baltimore, Sector Baltimore, Station Curtis Bay, Legacy Sustainment Support Unit, Asset Project Office, Human Resource Center, ESD Baltimore, HSWL, Engineering Logistics, Surface Logistics, Electronics Lab, and MSU Baltimore). The Coast Guard yard also housed two permanent cutters, the USCGC James Rankin and the USCGC Sledge.

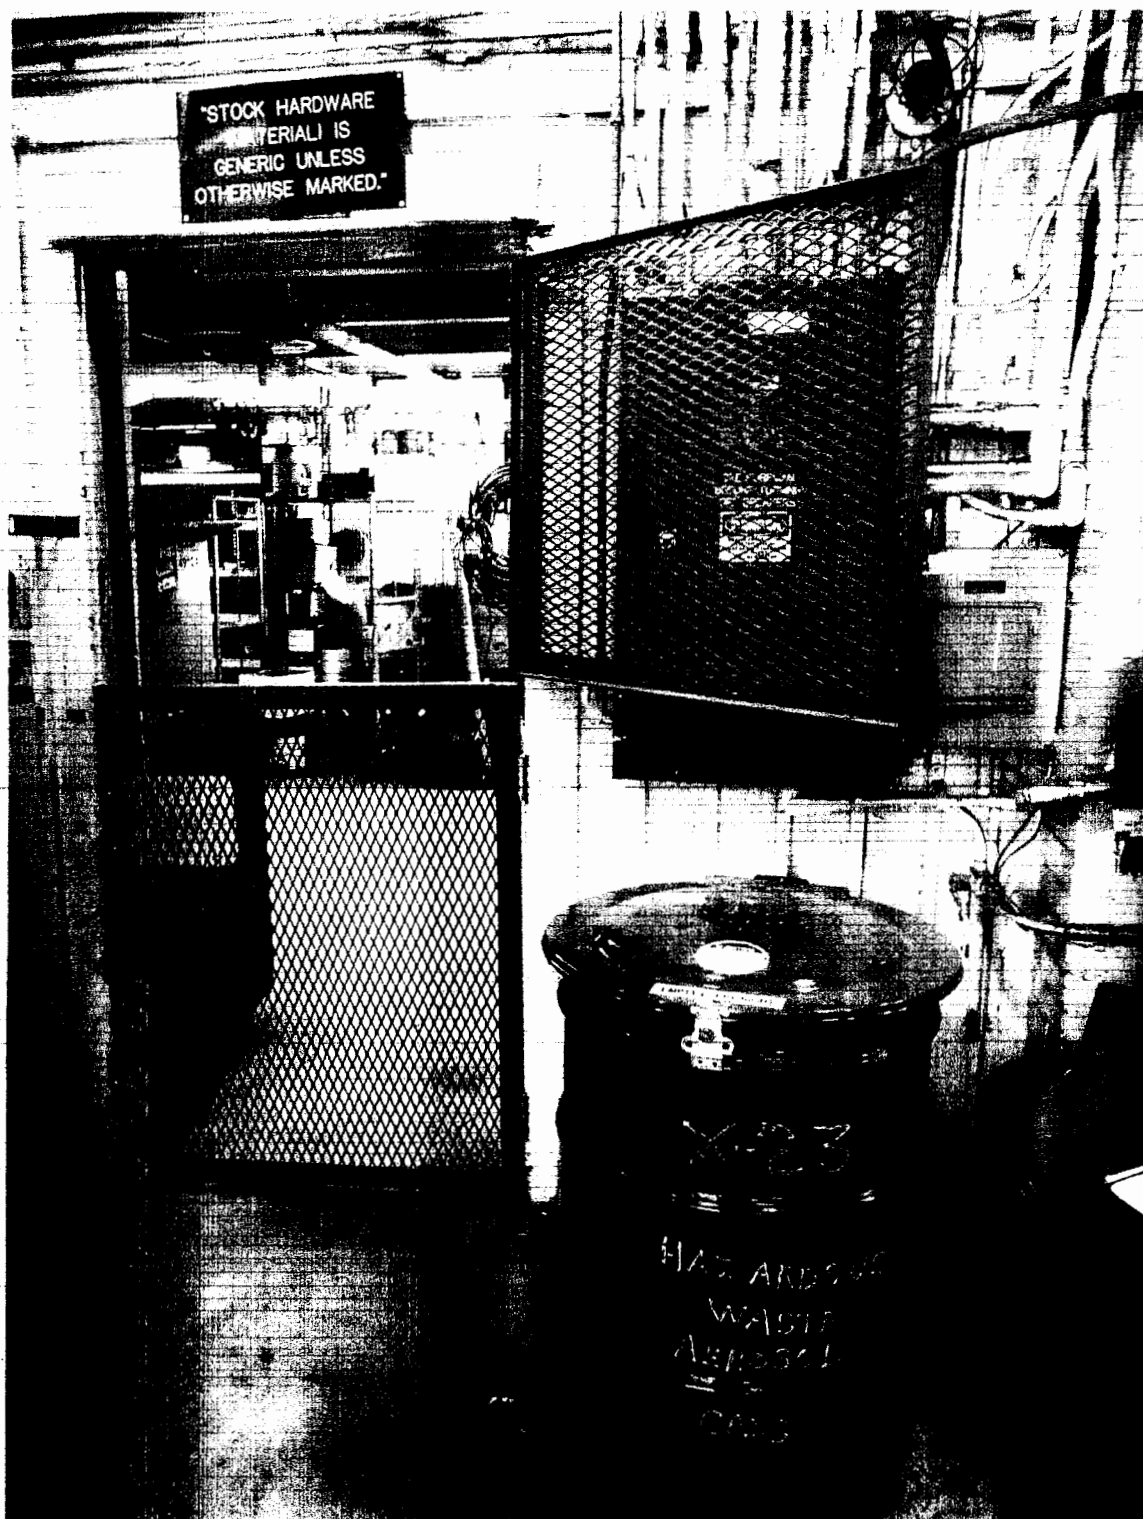
The main activity within this building is the maintenance and repair of vessel engines. The shop foreman for the building is Mr. Bob Byrd. The shop houses a 55 gallon hazardous waste SAA (**See Photo #1**). This SAA accumulates waste aerosol cans that are used throughout the shop. The drum is located next to the stock maintenance room. The drum was labeled with the words hazardous waste aerosol and had a closed lid. The EPA inspector viewed inside the drum, which was 2/3 full. Also located in this building is blasting booth (**See Photo #2**) and paint booth. The EPA inspector spoke with painter Mr. Mike Anderson. The blasting booth has a vented air system, which collects the fine blasting grit and deposits it into a 55 gallon drum located outside of the building. In conversations with the Facility, this waste stream is considered to be hazardous based on analysis. At the time of the inspection this collection drum did not have any hazardous waste label or contents (**See Photo #3**). The Facility was not treating this drum as a SAA for hazardous waste. Within the paint booth, there were multiple containers of liquid and semi-liquid contents (**See Photo #4**). Mr. Anderson stated this was waste that at the end of the day be carried outside to a hazardous waste SAA slop drum. The Facility has a SAA for slop waste from painting operations in the paint booth. This SAA is located outside of the building in a PIG containment unit (**See Photo #5**). The EPA inspector asked when the waste in the paint booth was generated and Mr. Anderson stated the waste was from the prior days activities and had been sitting in the paint booth overnight. There were no hazardous waste labels or contents marked on the containers in the paint booth. The SAA for the slop paint was closed with a label. The

Photo 1: Building 11 aerosol SAA

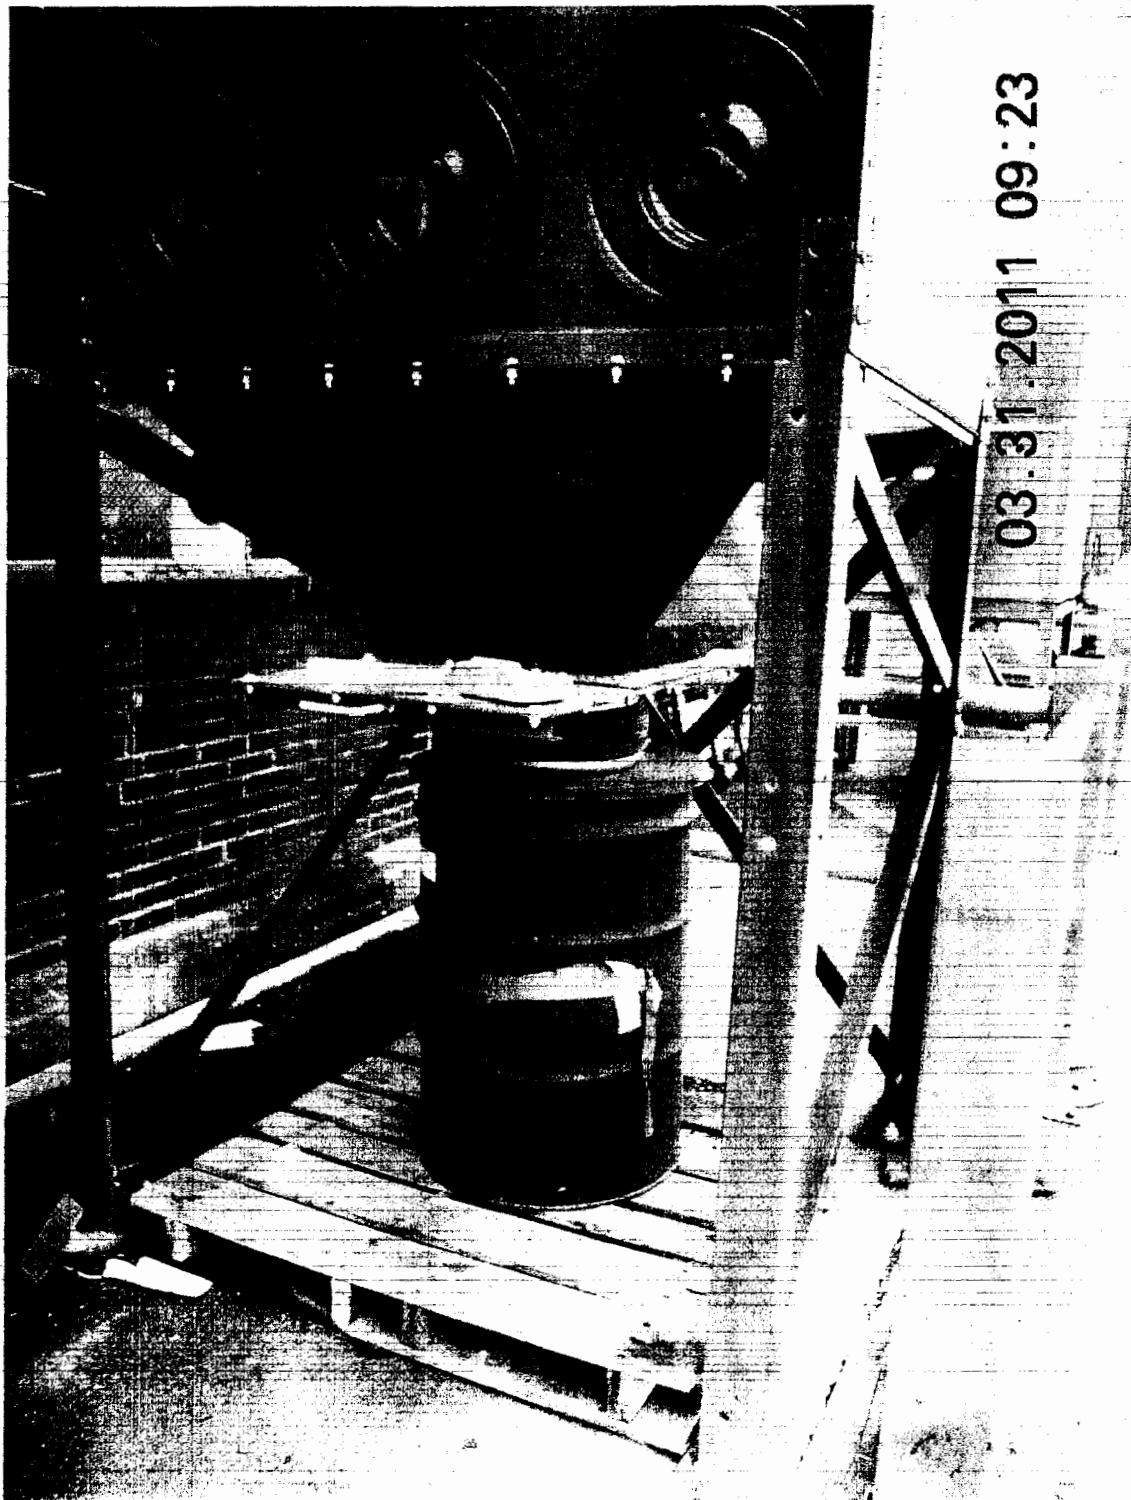
Photo 2: Building 11 blasting booth

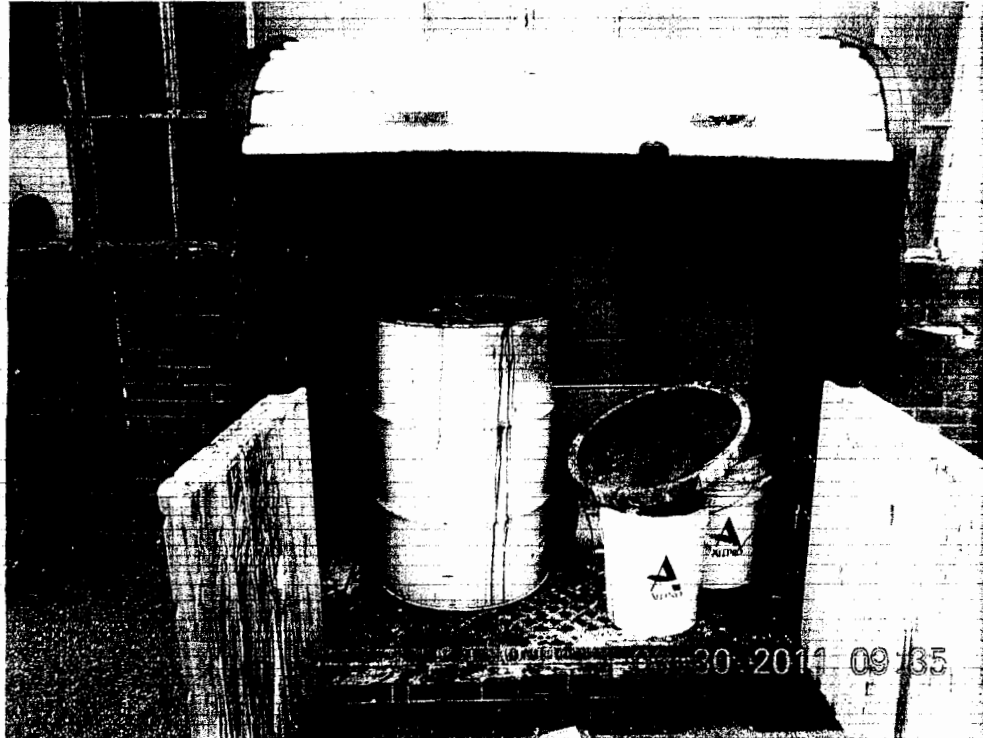
Photo 5: Building 11 paint slop SAA

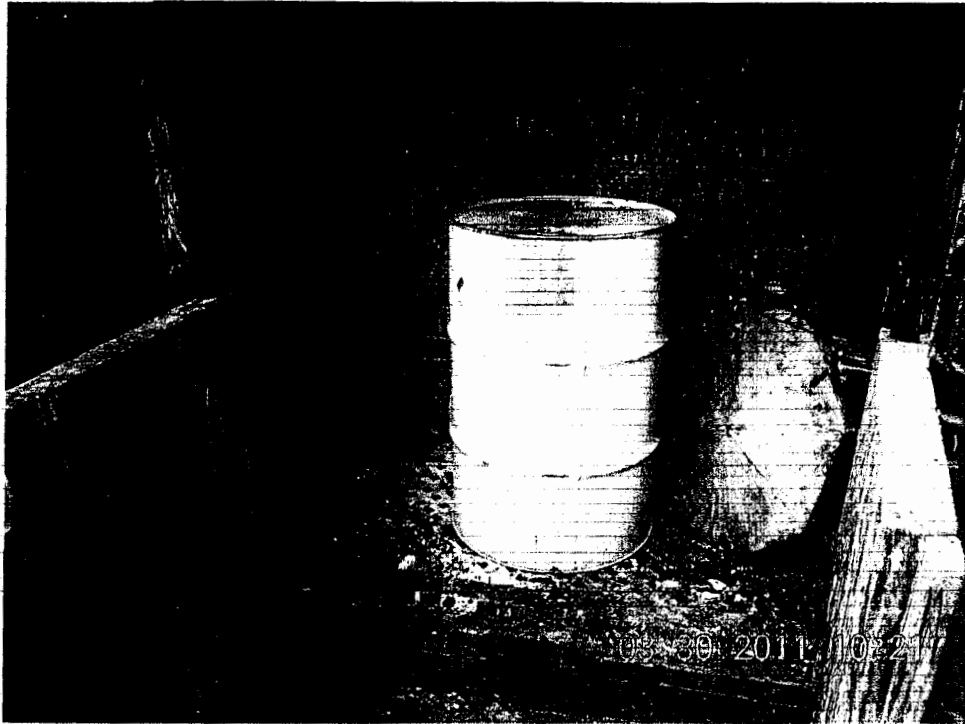
Photo 7: Building 32/90 SAA

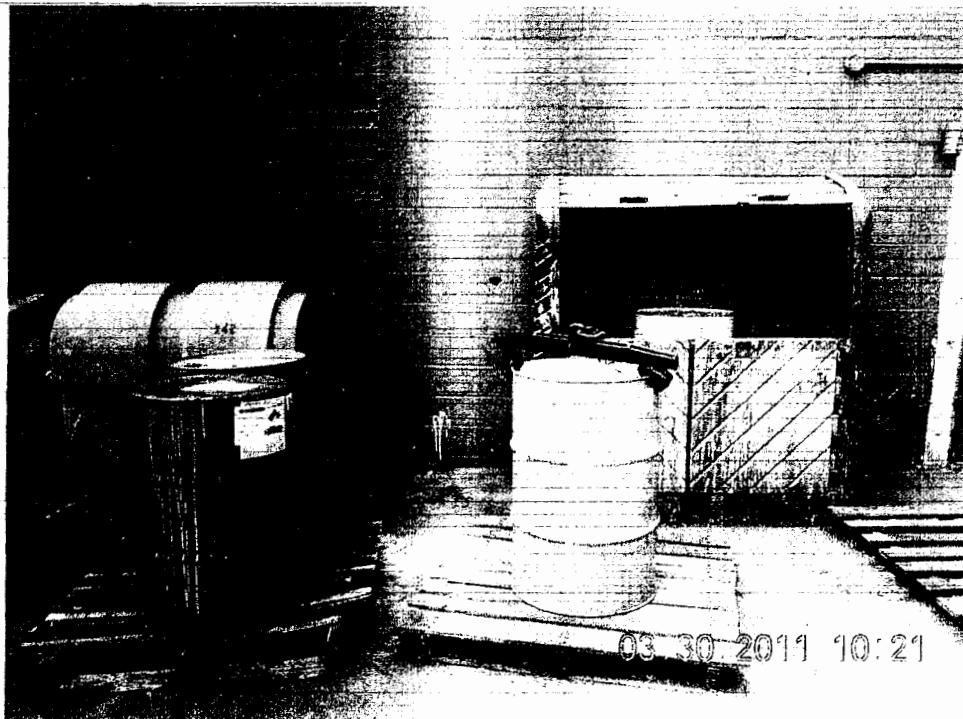
- 1) The inspector observer unlabeled and/or undated contains of hazardous waste at the following locations in violation of COMAR 26.13.03.05E(1)(e&f) [40 CFR 262.34(a)(2&3)]:
 - Bldg. 11 – Photo 4
 - Bldg. 32/90 – Photo 8 & 9
 - Rigging Shop – Photo 24
- 2) Open containers of hazardous waste were observed in violation of COMAR 26.13.05.09C [40 CFR 265.173(a)] at the following locations:
 - Bldg. 11 – Photo 4
 - Bldg. 40A – Photo 20

Photo 8: Building 32/90 drum staging area

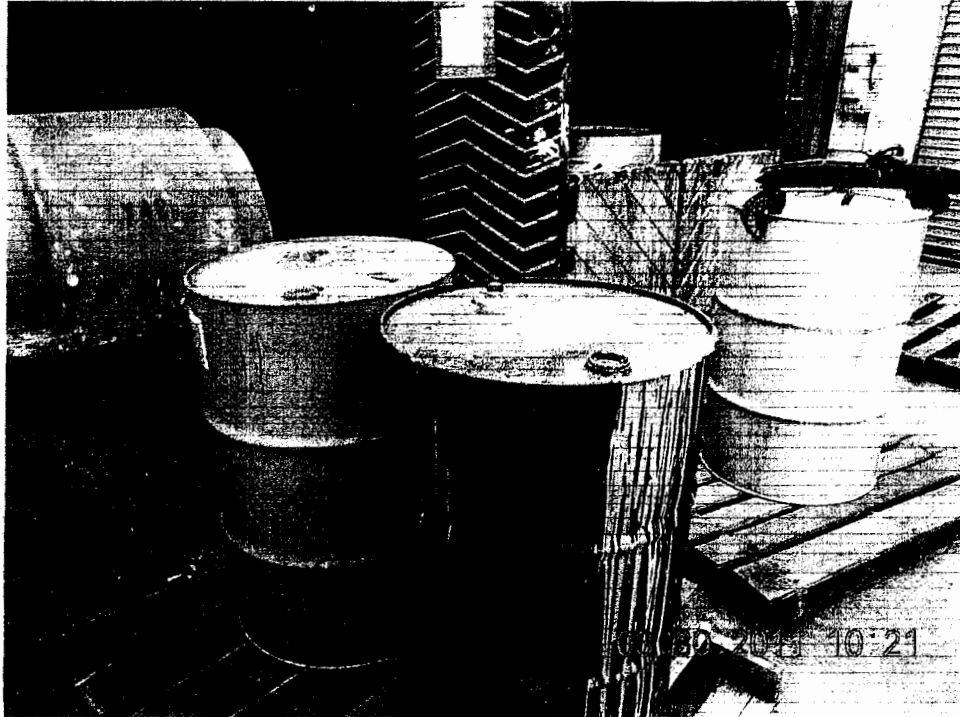
Photo 9: Building 32/90 drum staging area

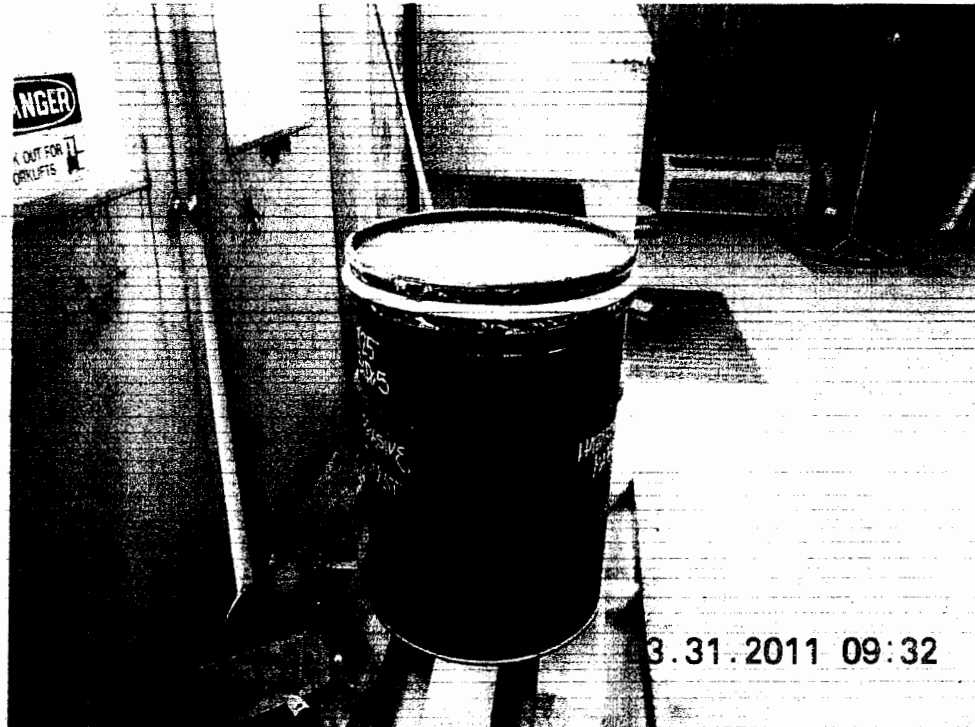
- 5) The management of the grit blasting residue both outside the trailer at Bldg. 5 (Photo 12) and inside (Photos 11,13, and 14) is a failure to maintain and operate the facility in a manner that minimizes the possibility of a release of hazardous waste or hazardous waste constituents and therefore a violation of COMAR 26.13.05.03B [40 CFR 265.31]

Photo 11: Building 5 trailer SAA

Previous laboratory analysis for the blast media waste stream determined that the blast residues or dust present in the building that houses the blast booths and within the dust collectors is non-hazardous. A second sample was collected from this waste stream on August 1, 2011, which also confirmed that the blast media waste stream is non-hazardous.

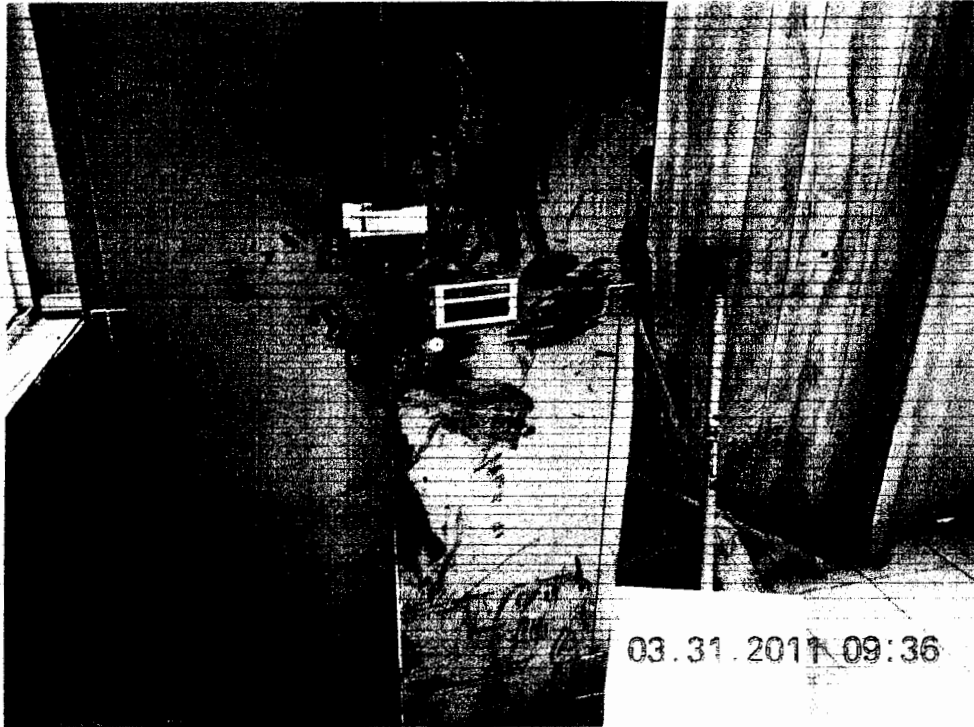
Photo 13: Building 5 trailer grit covering cabinet

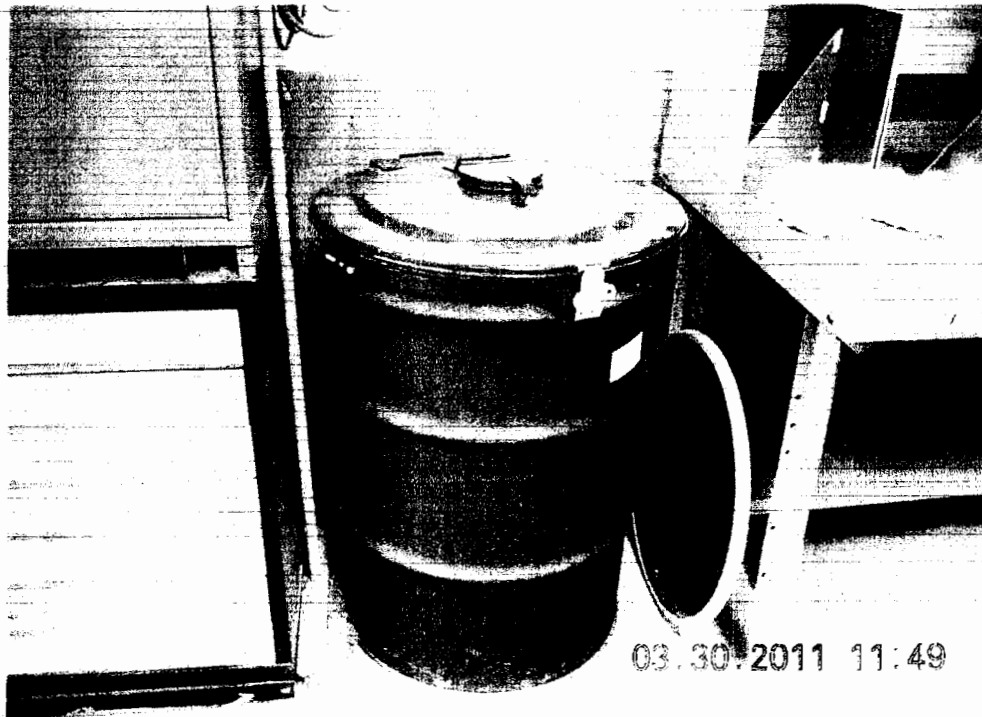
Photo 16: Building 40A small paint shop SAA no label

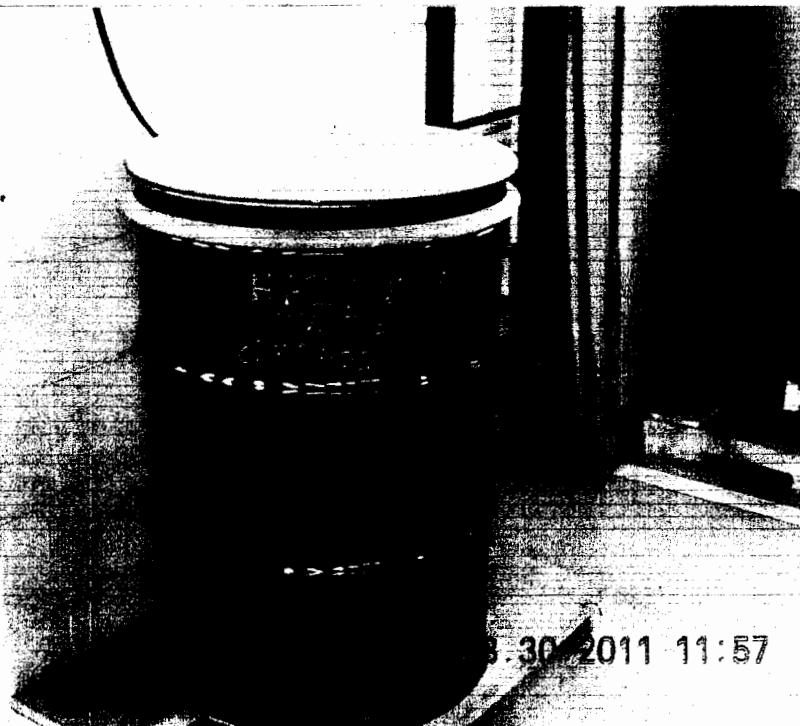
Photo 18: Building 40A incorrect hazardous waste designation

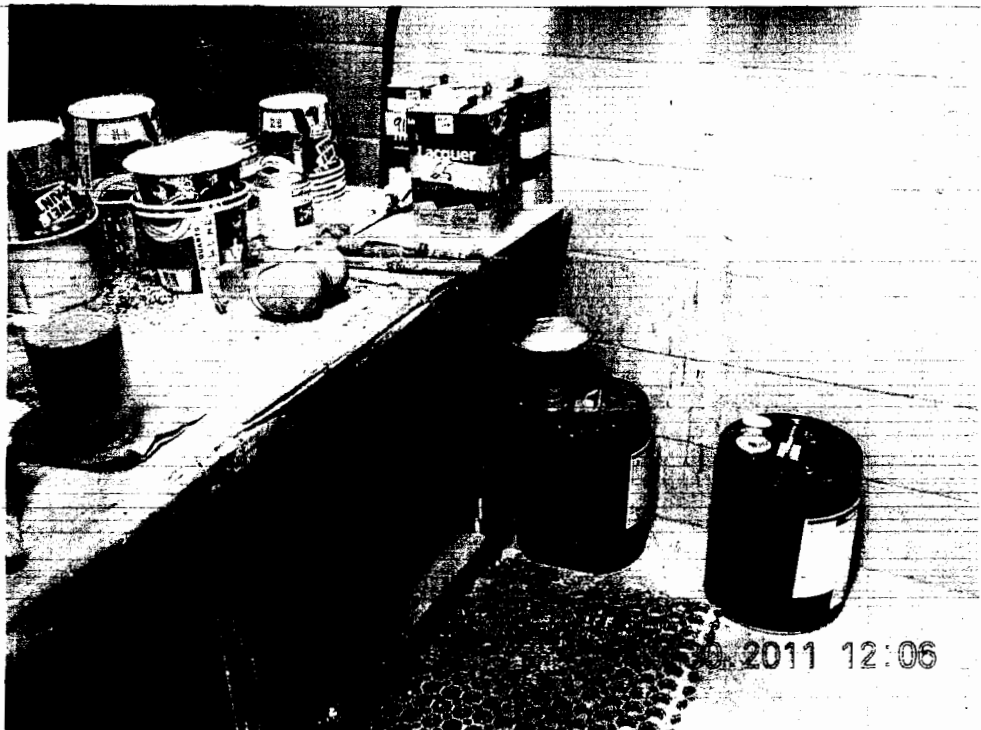
Photo 20: Building 40A waste-like thinner containers outside main electronic paint shop

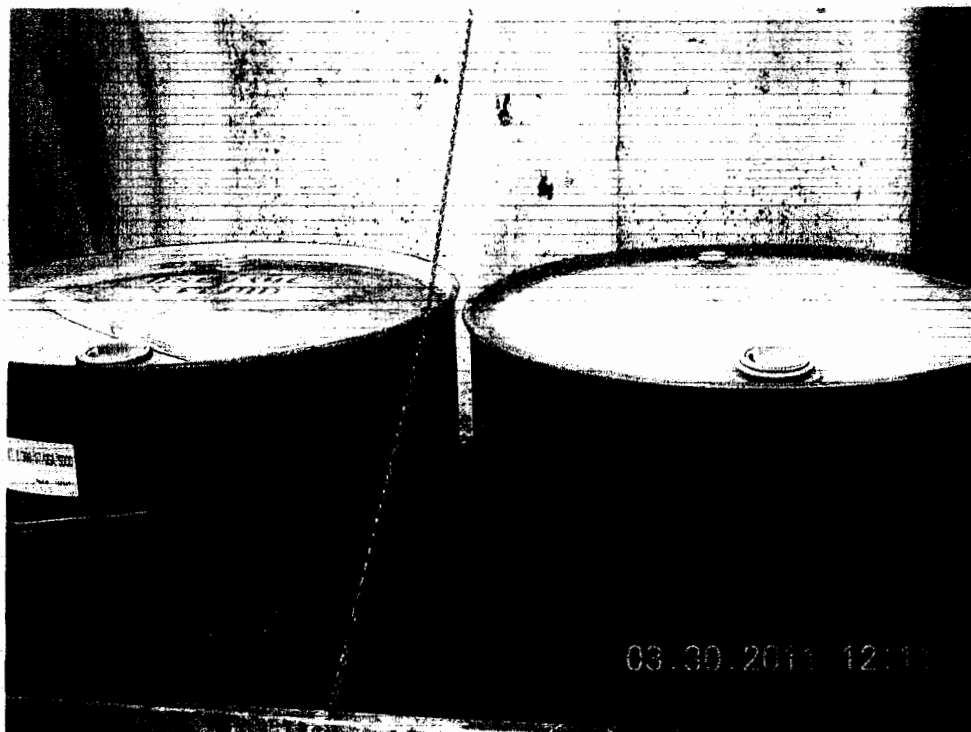
- 3) Satellite storage containers of hazardous waste with improper labels or without labels in violation of COMAR 26.13.03.05E(3)(b) [40 CFR 262.34(c)(1)(ii)] were observed at the following locations:
- Bldg. 11 – Photo 4
 - Bldg. 5 – Photo 15
 - Bldg. 40A – Photos 16 & 17
 - Oakridge Dry Dock – Photo 23
- 4) Satellite containers of hazardous waste that were not “at or near the point of generation” and/or “under the control of the operator” in violation of COMAR 26.13.03.05E(3) [40 CFR 262.34(c)(1)] were observed at the following locations:
- Bldg. 11 – Photo 5
 - Bldg. 32/90 – Photo 7
 - Bldg. 5 – Photo 12
 - Bldg. 40A – Photo 21

The main activity associated with this building is the rebuilding and installation of electronic systems on the vessels. EPA inspector met with electronic shop foreman Mr. Brian Ames. Within the front of the electronic shop the Facility has a small paint booth. Mr. Ames stated they only use paint cans to spray paint. The Facility had a black 55 gallon drum they were using to collect the waste aerosol paint cans. The cans were stated to be treated as hazardous waste but the drum did not have any type of markings denoting hazardous waste or the contents of the drum (**See Photo #16**). The EPA inspector observed the drum was ½ full. Once the Mr. Young relayed his concerns, the Facility labeled the drum detailing the contents as hazardous waste aerosol cans (**See Photo #17**). There was a black 55 gallon drum that stated hazardous waste oily rags (**See Photo #18**). Ms. Wisniewski stated this was an incorrect designation of the drum. The drum was not hazardous waste. The oily rags throughout the rest of the Facility were being treated as non hazardous waste. Located near a large main paint booth in the electronic shop was a grit blasting machine (Snap-On) (**See Photo #19**). The blasting grit is vacuumed up and put into a 55 gallon drum. The EPA inspector asked if the Facility had made a determination on the waste. The Facility stated they have analysis for the waste. The Facility then stated this machine has only been in use for a few months and they have not shipped out waste from this unit. Located outside of the paint booth was a container of thinner that had a funnel and appeared to be waste-like (**See Photo #20**). The EPA inspector asked who was in charge of the area and the Facility stated the painter Mike Rockocy. Mr. Rockocy was not present during the inspection. Outside of the building was a SAA for the paint slop from the paint booth. The drum was in a PIG containment unit, along with another drum that was labeled used oil (**See Photo #21**). The paint slop drum was empty at the time of the inspection.

Photo 21: Building 40A paint slop SAA

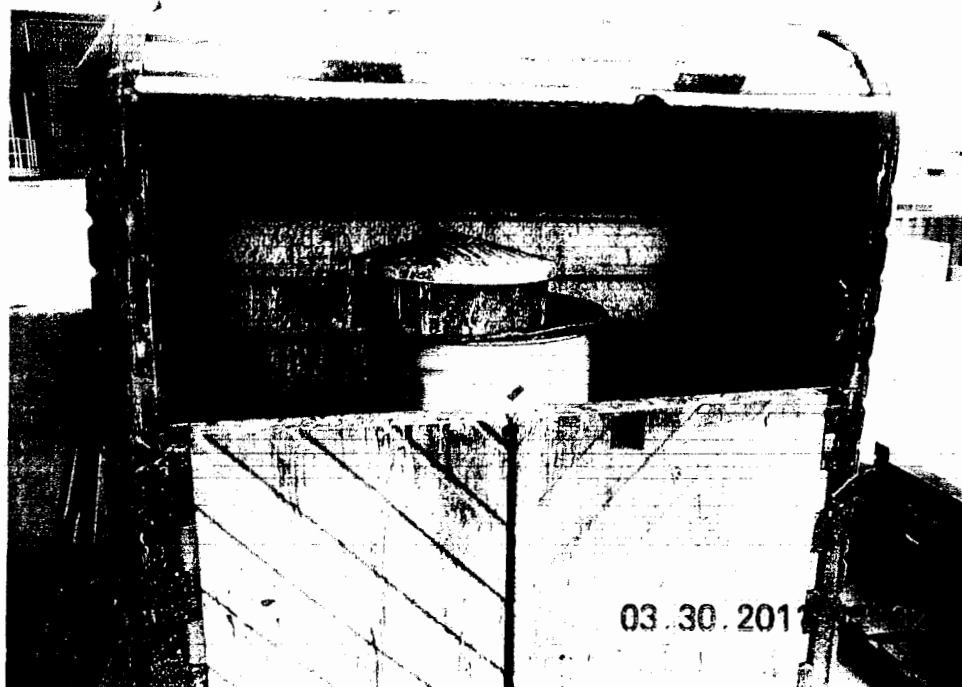
The main activity is the dry docking of Coast Guard vessels for repair and maintenance. The EPA inspector met with paint supervisor Mr. Larry Phinney. There is a SAA in a PIG containment unit. The SAA houses a tan 55 gallon hazardous waste drum (**See Photo #22**). There is a funnel on top the drum sitting in an open bung.

Photo 22: Shiplift SAA

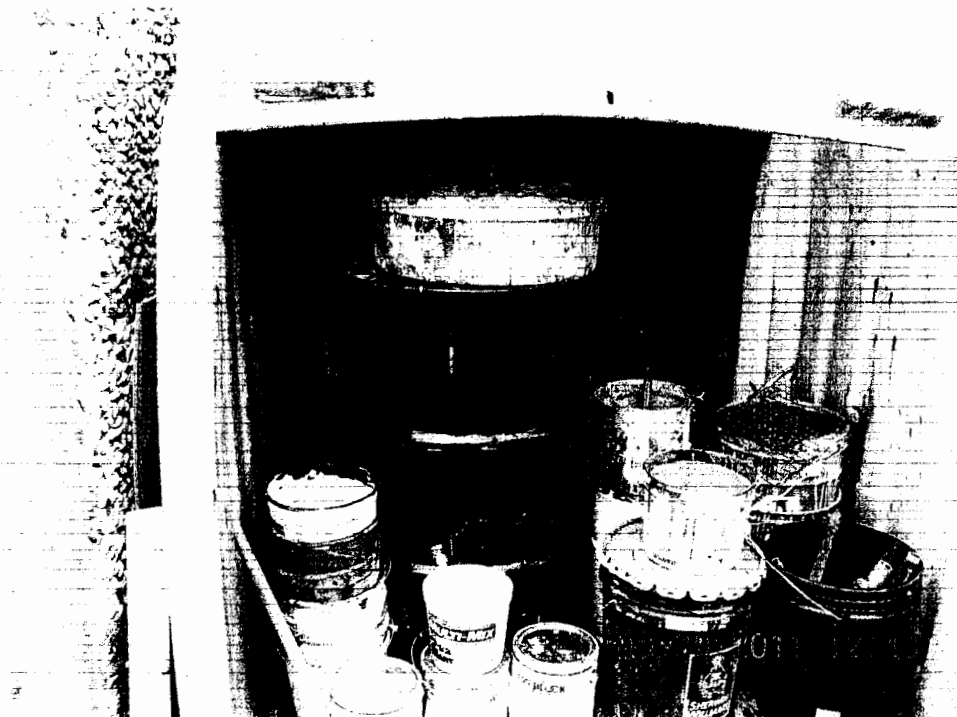
The main activity in this area is the maintenance and repair being conducted on the vessels from pier 1, 2 and Oakridge dry-docks. The SAA has a 55 gallon drum located in a PIG containment unit (**See Photo #23**). The drum was closed but there were no labels denoting hazardous waste or the contents of the drum. The Facility stated this drum is being treated as a hazardous waste drum. Waste being collected in this drum is from multiple generation points from pier 1, 2, and Oakridge dry-docks. There is no start accumulation date on the drum.

Photo 23: Oakridge Dry Dock SAA

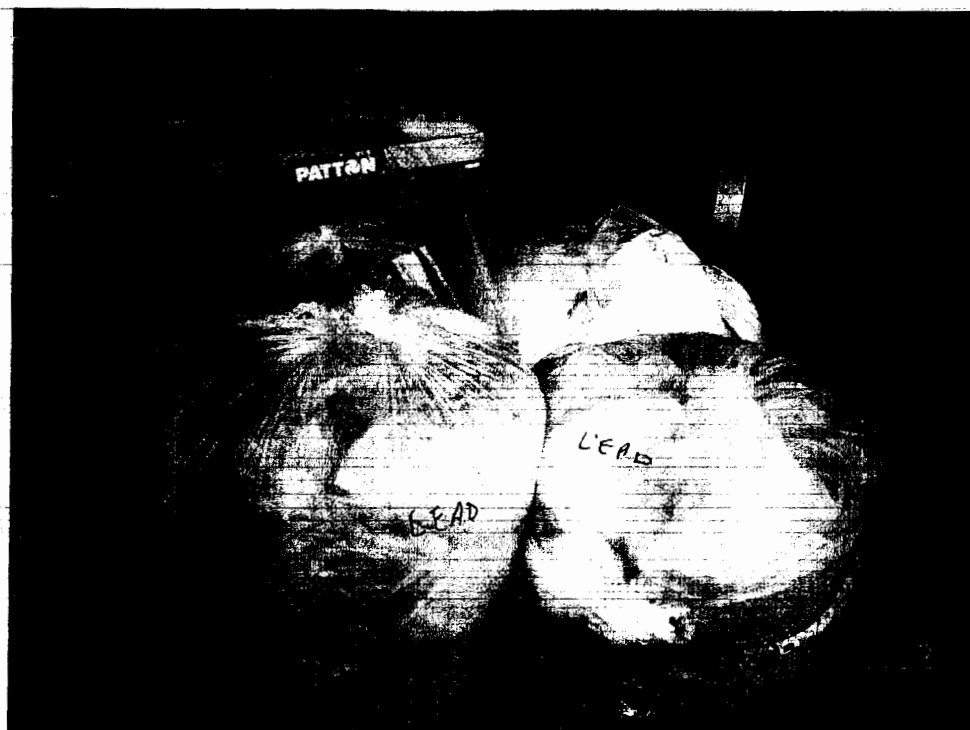
Located outside the rigging shop are clear plastic bags with the words lead on each container. The EPA inspector asked if this material is waste and the Facility stated yes these bags are lead waste that were generated from the cutting and pressing of lead ballasts (**See Photo #24**). The waste was stated by Ms. Wisniewski as going to be sent out as hazardous waste. There were no other markings on the bags. No hazardous waste labels or start accumulation dates. This area was not a designated SAA by the Facility.

Photo 24: Outside of rigging shop waste lead bags

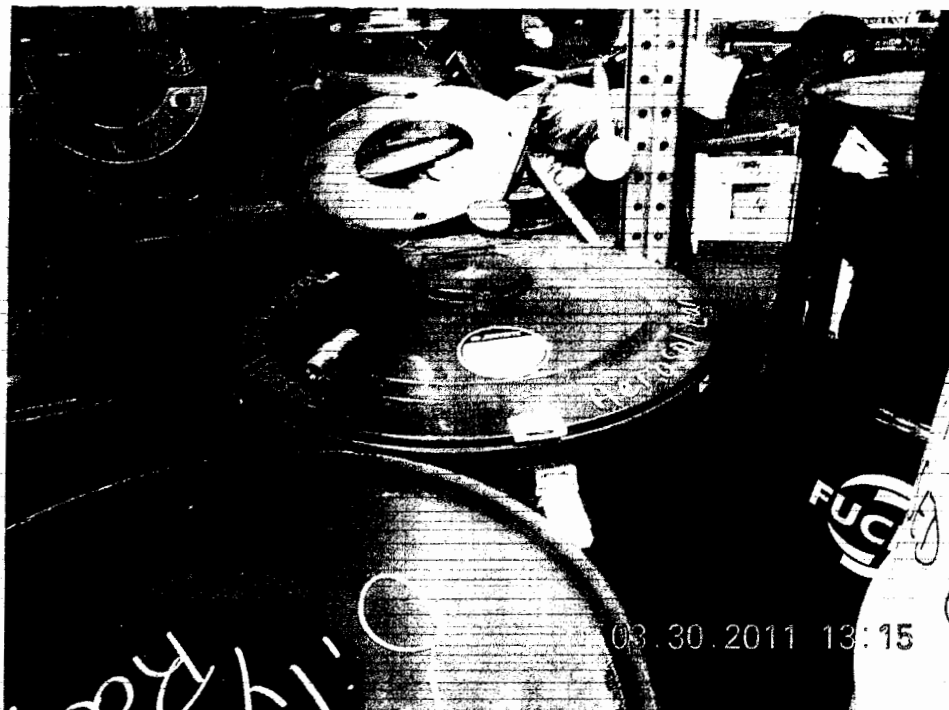
The activity within this building includes maintenance machine work. There is a 55 gallon hazardous waste drum for waste aerosol cans (**See Photo #26**). The drum was labeled and closed. The drum was observed to be ½ full.

Photo 26: Building 58 aerosol SAA

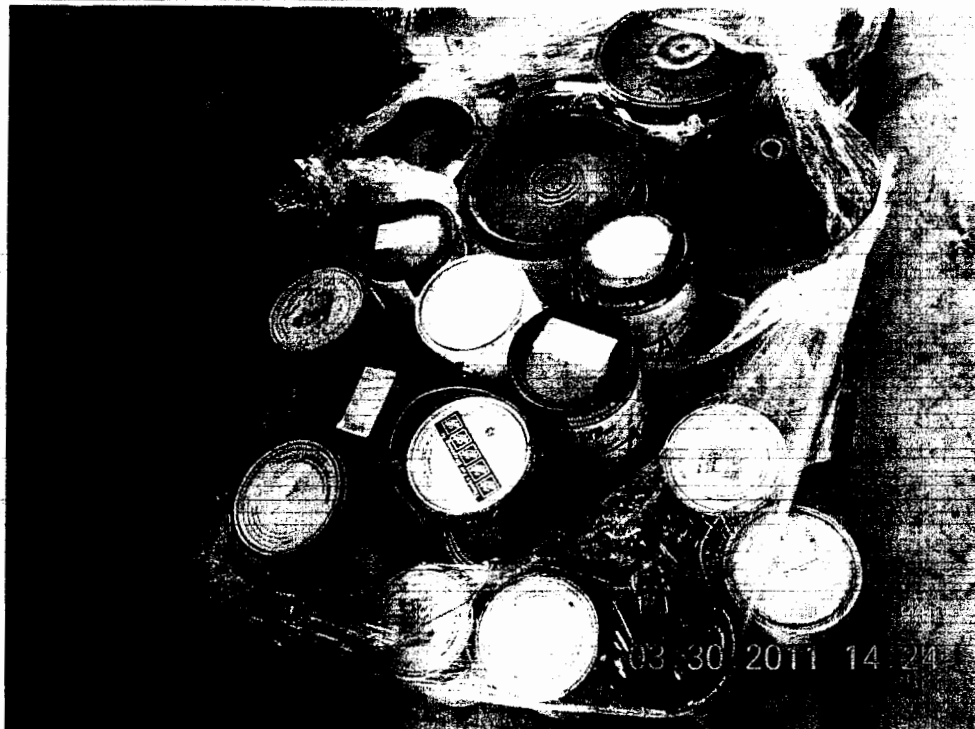
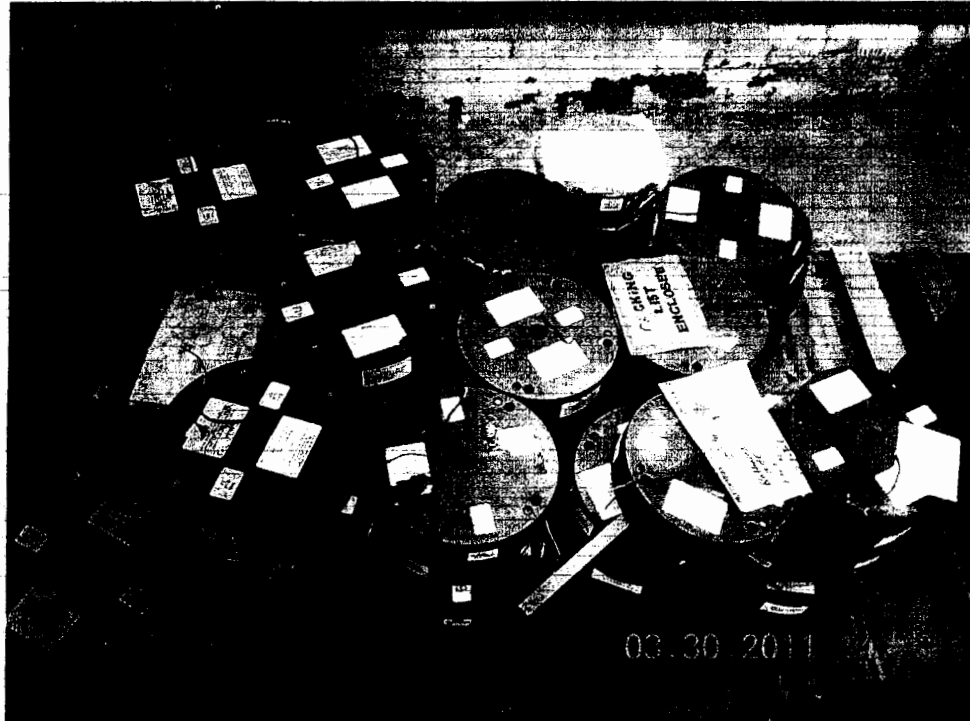
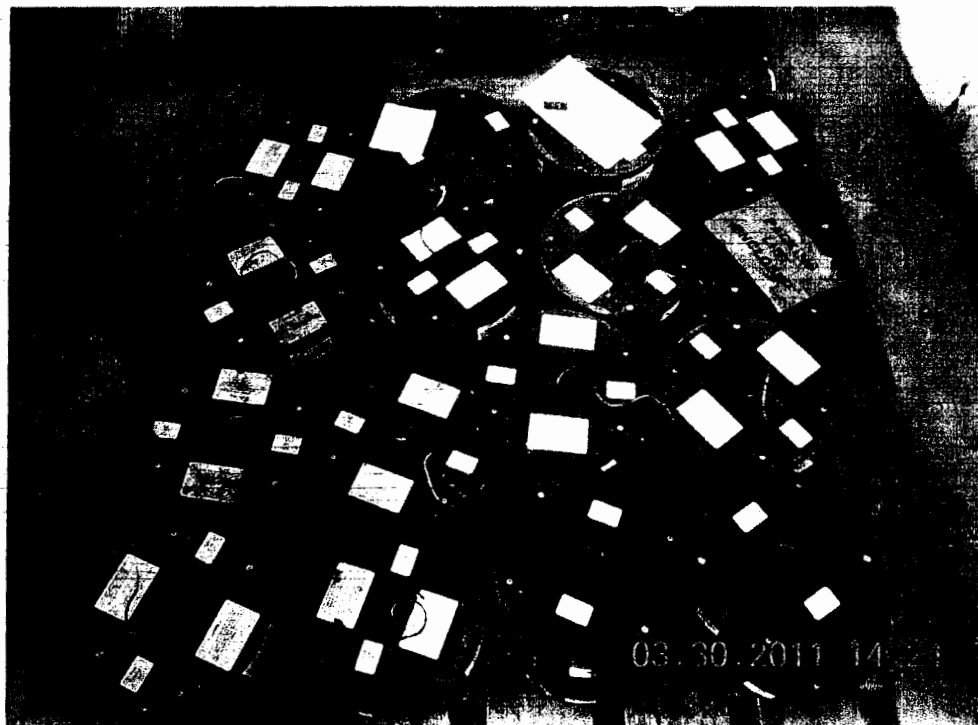
This building is the main accumulation area (MAA) for the Facility's hazardous waste before disposal. There were 17 drums of waste, 2 cardboard boxes of used mercury lamps, 1 red plastic container of hazardous waste gas, 1 can of finisher, 3 pallets of batteries, and 2 pallets of waste paint related material (See Photos #28 - #33). At the time of the inspection the oldest start accumulation date on the containers was 1/5/2011 (See Photo #34). The waste batteries and paint related material had a single hazardous and or universal waste label for each pallet. The finisher did not have any type of hazardous waste label or associated start accumulation date. The original label warned the material is flammable (See Photo #35).

Photo 30: MAA overviews

Photo 31: MAA overviews

Photo 32: MAA overviews

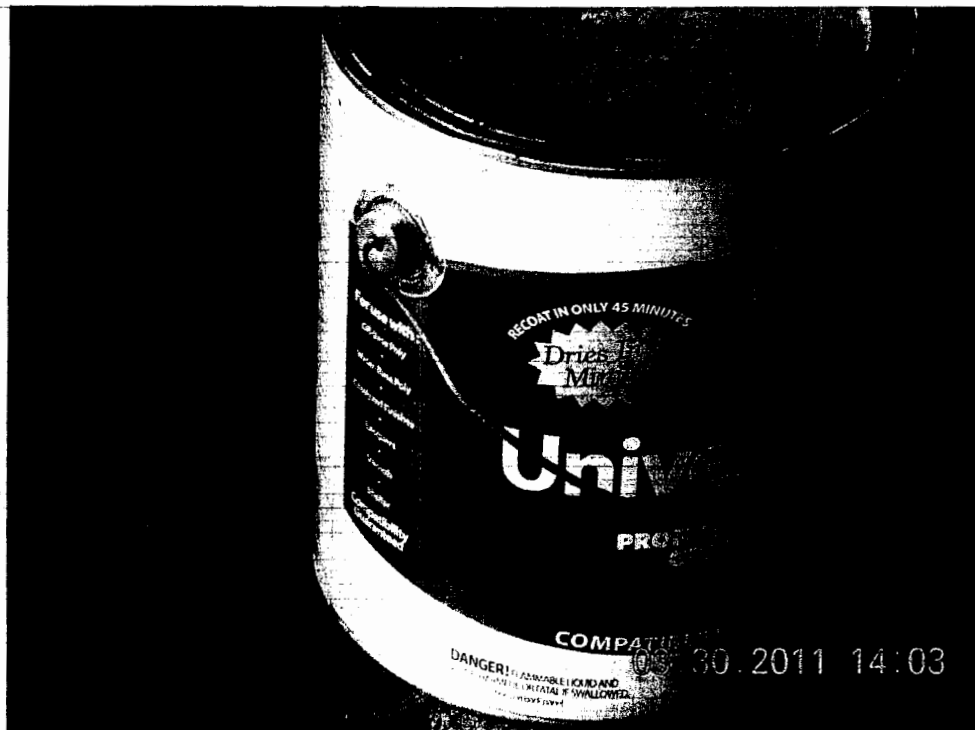
Photo 35: Flammable finisher can in MAA with no label or date

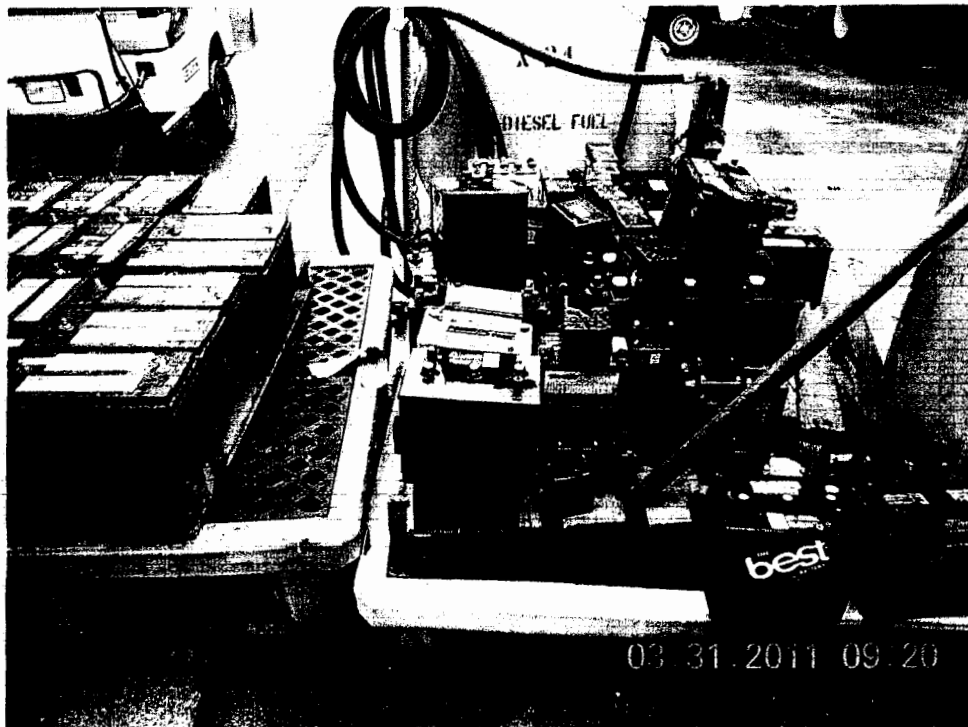
The Facility was storing there waste lead acid batteries outside next to building 66. The Facility employees either bring the batteries over directly or contact Ms. Wisniewski to come and pick up the batteries. At the time of the inspection there were two full pallets of lead acid batteries. The Facility stated they have an agreement with an outside company to pick up the batteries for recycling. The garage supervisor, Mr. Bob Kline is in charge of calling for a battery pickup. There were no start accumulation dates or universal waste labels on any of the batteries (See Photos #36 - #38).

Photo 36: Lead/acid battery storage area
